**IDENTIFICATION AND DELINEATION
OF URBAN RIPARIAN ZONES
AND THEIR INFLUENCE ON
LOCAL ENVIRONMENTAL CONDITIONS**

Final Report

**James E. Mitchell
Institute for Environmental Studies
Louisiana State University
Baton Rouge, LA 70803**

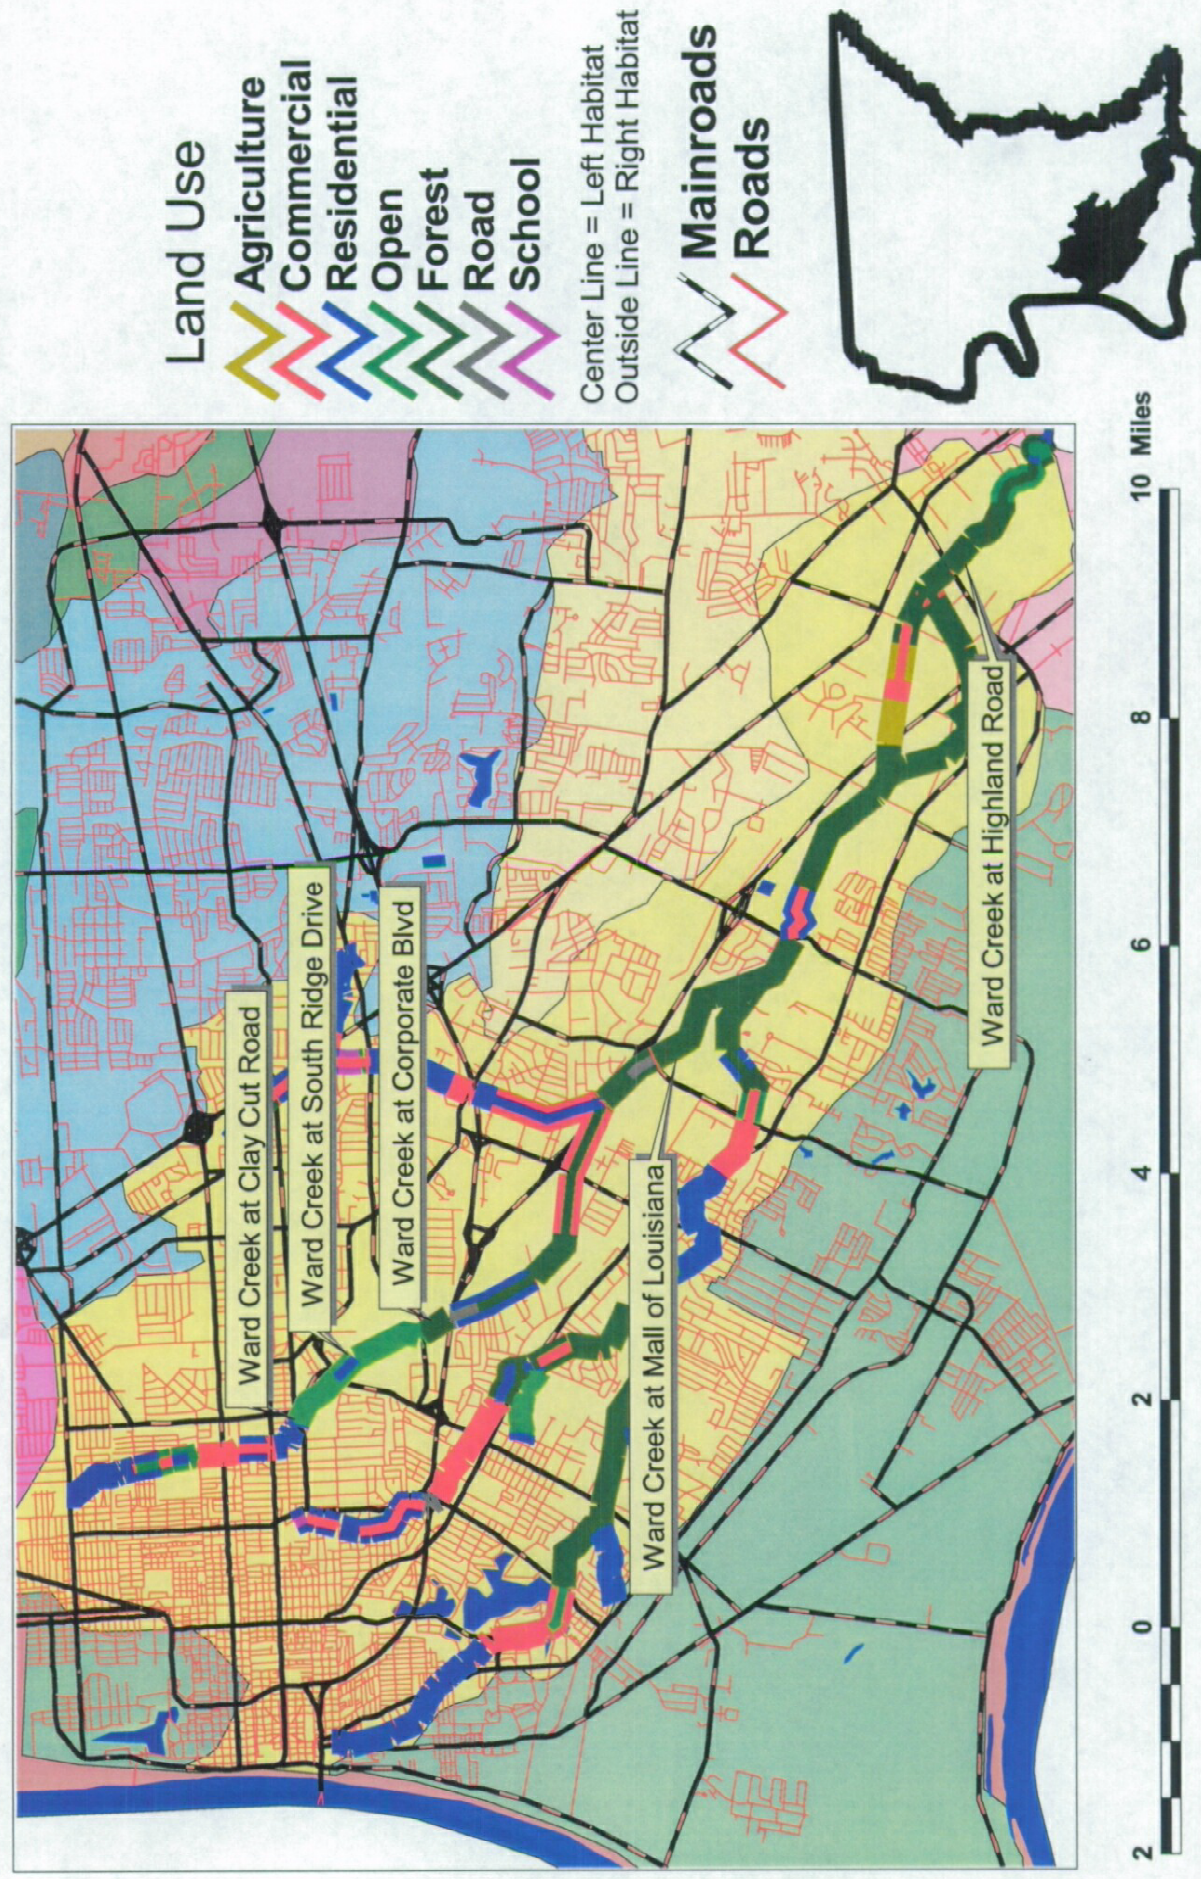
Figure 6. Near-stream land use of Ward Creek

Figures 6 and 7 depict the near-stream land use and riparian habitat data in the Ward Creek watershed. A complete inventory for East Baton Rouge Parish Basin Groups can be seen in Appendix C, as maps (Figures C-1 – C-10).
